MARIOLAKOS, I., FOUNTOULIS, I., (1998). – Is it safe to built on fault surfaces in a seismically active area? The case of Eleohori village (SW Peloponnessos, Greece). In *Proc. Of the 8th IAEG Congress Vancouver Canada 21-26 Sep. 1998*, 665-670.

Is it safe to build on fault surfaces in a seismically active area? The case of Eleohori village (Southwestern Peloponnessos, Greece)

I. Mariolakos & I. Fountoulis

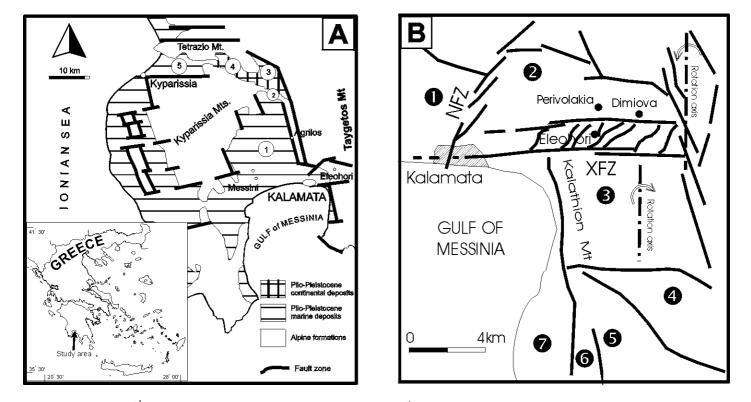
Eleohori has been founded on the transition fault zone between the Kalathion Mt. horst to the south and the Dimiova - Perivolakia graben to the north (Xerilas fault zone) (Fig. 1B). A number of parallel big faults in en echelon arrangement striking E-W constitute the fault zone. It is a typical scissor fault zone and the vertical throw is zero at the eastern part and increases towards west. At the western part of the fault zone the total throw is more than 2.000m (Mariolakos *et al.*, 1986, 1989).

Figure 1 (A) The 2nd order neotectonic macrostructures within the 1st order neotectonic macrostructure of Kalamata-Kyparissia graben. The numbers correspond to the following 2nd order neotectonic macrostructures: 1:Kato Messinia sub-graben, 2:Meligalas horst, 3:Ano Messinia graben, 4:Dorion basin, 5:Kyparissia-Kalo Nero graben. (B) Sketch map of smaller order neotectonic

macrostructures of the Kato Messinia sub-graben 1:Asprochoma-Koutalas horst, 2:Dimiova-Perivolakia graben, 3:Kalathion Mt. horst, 4:Altomyra semi-graben, 5:Kambos graben, 6:Vardia-Koka horst, 7:Kitries-Mantinia sub-graben, XFZ:Xerilas Fault zone, NFZ:Nedon Fault Zone

i. Localization, mapping and tectonic analysis of the neotectonic macro-structures and mainly the great active fault zones which define their margins. Areas belonging in such zones are not favorable for construction foundation as the frequency and the density of the tectonic discontinuities should be great compared to other areas. They change (influence) greatly the (primary) original characteristic of the rock-mass and the most of them have the characteristics of the active ones and it is most likely expected to be reactivated by a future earthquake. Eleohori village for example has been built on such big fault zone named Xerilas fault zone, which bounds the southern margin of an active neotectonic graben the Dimiova – Perivolakia graben. The Kalamata earthquake reactivated this graben. The city of Kalamata has been built on the cross point of the prolongation of two such big fault zones, namely the Xerilas (XFZ) and the Nedon (NFZ) (Fig. 1B).

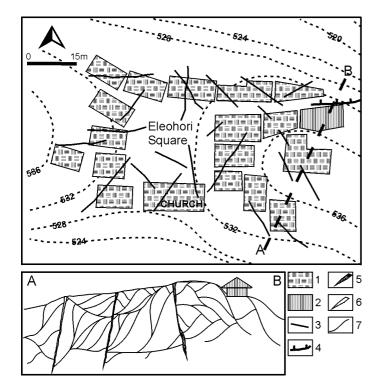
fractures, which have been reactivated during the seismic activity (seismic faults and fractures). The more intensive damages have been observed on the cross points of two sets of seismic fractures. The most characteristic case is that of the small square of the village, where all buildings around it have been totally destructed, although the foundation conditions were favorable. The morphological gradient was not higher than 5%, whereas the quality of the rock mass would be good enough if it was not crossed by a great number of discontinuities. The detail mapping of the area after the main shock as well as after the aftershock has shown that the area is crossed by many seismic fractures (Fig. 3).

- vii. The two old houses of the village that remained untouched are the best example to study the crucial role of the reactivation of specific faults and/or fractures on the distribution of the damages (Fig. 3). Both have been built on a fault surface striking E-W, which constitutes the contact of the neritic carbonates and the flysch sediments of the Tripolis geotectonic unit. This fact is very impressive and can be explained (interpreted) if somebody takes into account the kind of the fault surface, as it is a typical alpine inactive fault surface and the building has been founded on the massive rock-mass. So, in spite the fact that (a) the two houses were among the oldest ones, and (b) the morphological gradient in this site is

Figure 3 Correlation between the type of fractures (active – inactive) and the damages in Eleohori. 1:Damaged houses, 2:non-damaged house, 3:seismic faults and fractures, 4:inactive fault, 5:active fault reactivated by the Kalamata earthquake, 6:active fault non activated by the Kalamata earthquake, 7:inactive curved fault surfaces

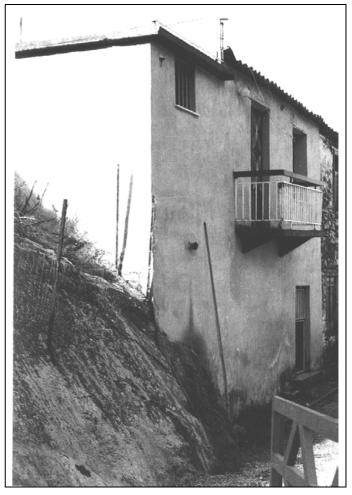
relatively high, none of these houses suffered any damage (Fig. 4).

Figure 4 Two old houses remained untouched after the earthquake, although they have been built on an old inactive fault surface but on a massive rock body (neritic carbonates)
