MARIOLAKOS, I., FOUNTOULIS, I. & ANDREADAKIS, M., (2000). – Engineering Geological problems caused by human interference on monuments that influence their seismic behaviour. In RAPHAEL programme – COMARECH, “Compatible materials and techniques for earthquake and monuments protection”, p. 53-63, Istanbul, October 2000.

ENGINEERING GEOLOGICAL PROBLEMS CAUSED BY HUMAN INTERFERENCE ON MONUMENTS THAT INFLUENCE THEIR SEISMIC BEHAVIOUR (FOUR CASE STUDIES)

I. Mariolakos, I. Fountoulis & E. Andreadakis

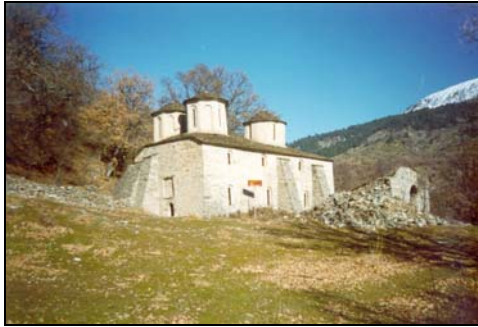
The monastery was originally built in the 17th century AD (Figure 1), and an overhaul took place in the 1810-1820s. In the 1920s large support walls were

Figure 1: The temple of the Monastery of Zerma and the surrounding collapsed cells.

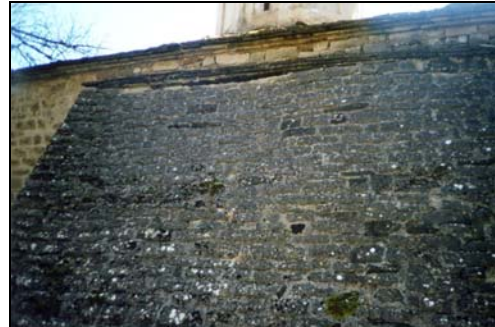
Figure 2: The detachment of the thick supporting wall from the wall of the temple on the north side of the temple

A differential subsidence is taking place also around and inside the temple. As a result, a tilting of the columns is observed, as well as expanding fractures, especially on the eastern wall of the temple, and on the outer walls of the collapsed cells. The walls and the structural elements of the temple have started to separate (Figures 2, 3).

Amounts of water are artificially drawn from a spring uphill to the surroundings of the monastery to create a fountain, charging the loose eroded ground and actually worsening the geotechnical features. The large supporting walls built in the 1920s, instead of supporting the declining walls of the temple, they have actually added a great weight to the sides, thus dragging them downwards, and facilitating soil compaction and creep.

Drainage of the surface water, away from the surrounding area is proposed, in combination with removal of the additional weight of the thick supporting walls. Also, bushing should be done downhill from the monument, and the situation – water table level and any vertical and horizontal movements – should be monitored.

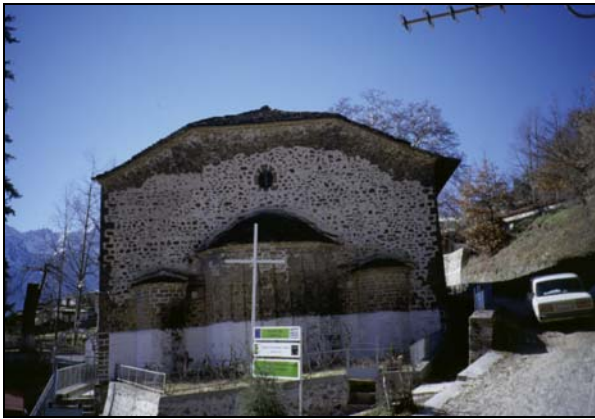
Figure 4: The deformation of the shape of the temple in Paleoselli is quite impressive, once no fractures have been observed on the walls.

A rather impressive deformation of the temple has taken place, with differential subsidence inside the temple and tilting of columns both increasing from the northwest corner to the southeast corner. However, no fractures have been observed on the walls and no detachments at the joints of the structural elements, while the shape of the temple resembles a distorted matchbox (Figures 4, 5).

There seems to be a mechanism of differential subsidence, directly connected to the differential saturation of the soil. The spatial differences of saturation created different plasticity and compressibility conditions, which, combined with the heavy load of the building, triggered differential subsidence. Thus, the northeast area is supersaturated, while the southeast area is undersaturated, because of the interruption of the subsurface water drainage by the construction, and the absorption of large amount of underground water by the sycamore tree. No fractures have damaged the walls, because of the excellent framework with joints of the pillars and the walls with metallic elements and beams.

Surveillance of the evolution of the deformation of the temple is proposed, in combination with gradual drainage of the underground water uphill.

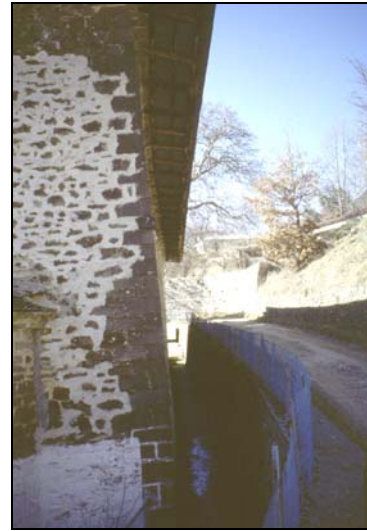
Figure 5: The northern side of the temple. The seepage is obvious, as well as the tilt of the shape.

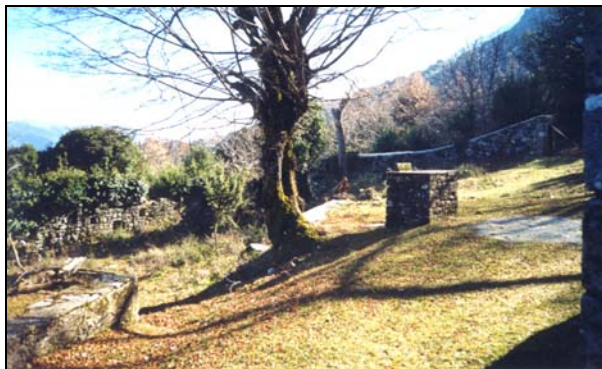
Figure 7: Creep phenomena outside the temple (east-northeast).

Subsidence is observed at the northeast corner of the shed and steeple, as well as Expanding fractures on walls of the added wing, and the surrounding stone fence along the perimeter. Creep phenomena are also obvious on the slopes (Figures 7, 8).

The addition of the new wing and the excavation for the opening of the road without any supporting of the cut slope, have accelerated the creep phenomena and expose the temple to a hazard that had not existed before.

Light supporting wall (with drainage) at the recent cut of the road and bushing on the slope are proposed to protect the foot of the slope that supports the monument. There should be peripheral drainage around the perimeter, and instrumentation for the monitoring of the creep phenomena and the water table level should be established.

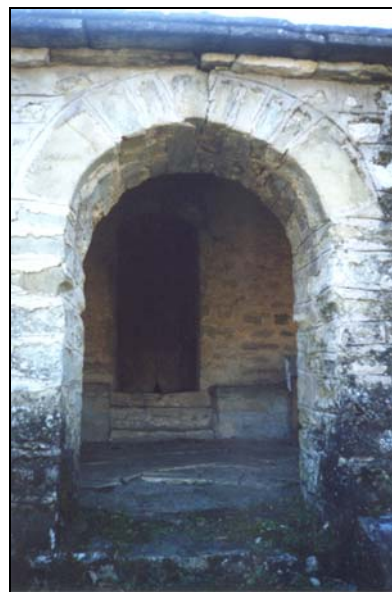
Figure 8: The entrance of the temple (north side). The fracture at the top of the span is due to subsidence on the left (northeast corner).

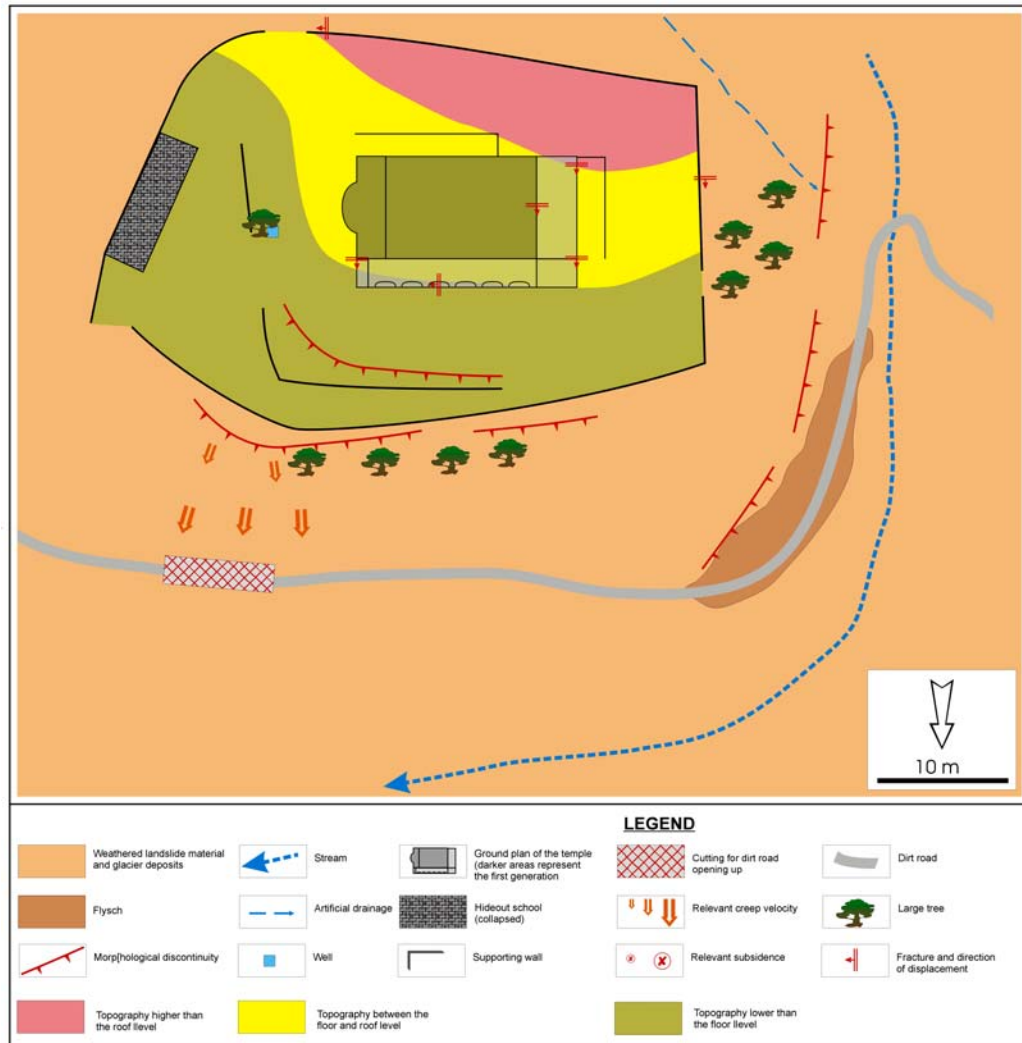
Figure 9: Sketch map of the monument in Dramesioi and the surrounding area.

rainfall and large amounts of drainage. It is worth mentioning that the elder (original) part of the building had not presented any problems before the additional constructions, and that the creep phenomena seem to be accelerating after the cutting of a downhill slope for opening up of a dirt road (Figure 9).

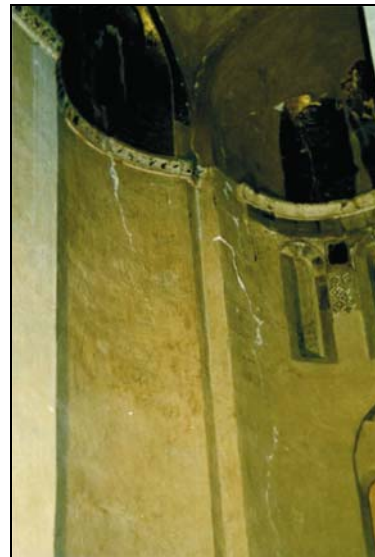
Figure 11: Fractures within the temple.

Fractures in the nave are observed throughout the temple, especially at the higher parts (Figure 11). A large - scale strike slip fracture is developing outside the surrounding wall along several tens of metres. The surrounding wall has partially collapsed.

All damages occurred during the earthquake, and they are connected with seismic fractures on the ground, or the extensions of these fractures. The damages are due to the presence of the marginal fault of the graben, along which seismic energy is very high.
