INTERNATIONAL MEETING

On results of the May 13, 1995
earthquake of West Macedonia:

**School Buildings and Antiseismic Planning.
The Example of Grevena - Kozani Earthquake
(W. Macedonia, Greece) of May 13, 1995.**

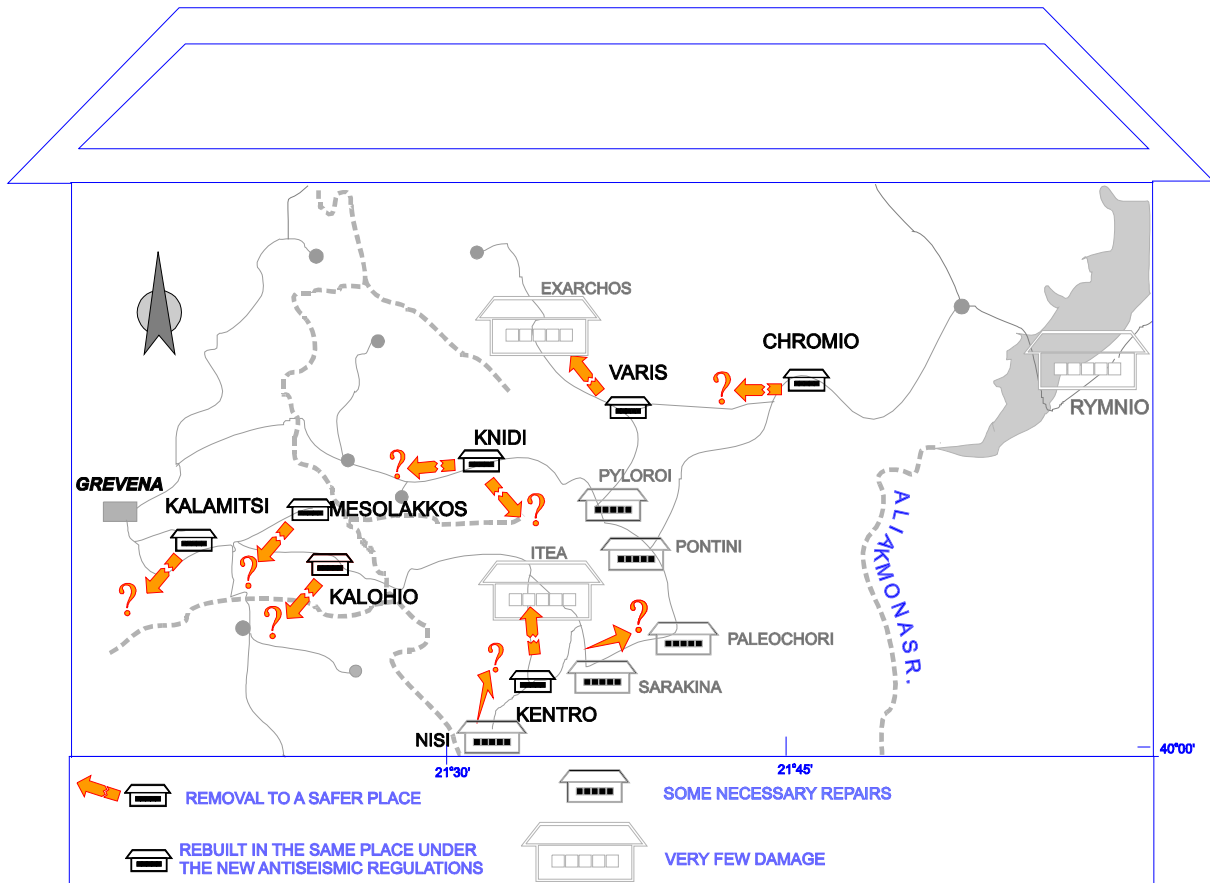
Using this earthquake as the case study, an attempt will be made to determine the factors that played a significant part on the distribution of the damage of school buildings. The pleistoseismal area has numerous small villages and communities, where the school buildings are mainly old constructions, housing one or two classrooms. Most of them collapsed or were seriously damaged (Fig. 1).

It is noted here that the overall distribution of the damage in the school buildings follows that of the other constructions. Thus, out of 30 villages where damage 17, at 6 cases the school buildings collapsed, 3 suffered extensive damage and all the others were lightly damaged (Carydis et al 1995, Lekkas et al 1995).

Fig. 1: The distribution of the school buildings damage and the synoptic proposals.
