**LEKKAS, E. & FOUNTOULIS, I., (1998).** - The Umbria (Central Italy) earthquake series of September, 26, 1997. *In Risk Analysis (Edit. Brebbia, Rubio, Uso)*, 93-102, WITPRESS

## **The Umbria (Central Italy) earthquake series of September 26, 1997**

E. Lekkas & I. Fountoulis

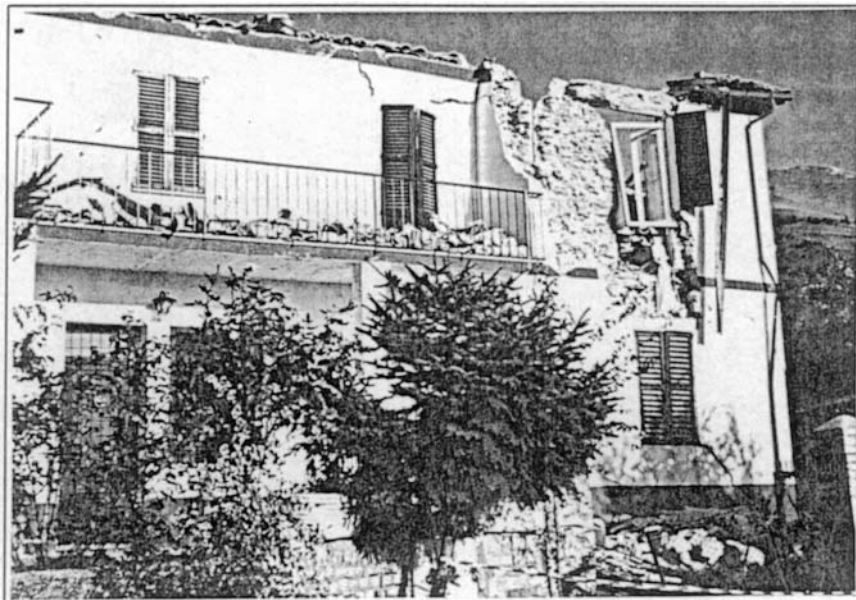
Figure 3: Collapse of the two-story building rubble masonry, in the settlement of Cesi.

The observed structural damage included many items that would result in a threat of life. The typical failure was in the outward movement of the wall, due to the deflection of the diaphragm pushing the wall outward. This, coupled with inadequate anchorage between the walls and roof, resulted in the wall collapse. In some cases portions of the walls were blown outward. Such type of collapse cause roof collapse too. Many structures had earthquake tie rods visible on the exterior walls (Fig. 3, 4).
