Environmental effects caused by the Andravida (08-06-2008, ML = 6.5, NW Peloponnese, Greece) earthquake

ABSTRACT: On June 8th 2008, and 12:25:28:0 UTC, an earthquake of ML = 6,5 and D = 15–21 km stroke NW Peloponnesus in Western Greece. Secondary environmental effects were classified as (a) landslides and rockfalls, (b) surface fractures and (c) liquefaction phenomena. Landslides and rockfalls were associated with (a) geological formations with characteristics that make them susceptible to failure, (b) strong heterogeneity, (c) the intense fracturing and weathering and (d) the tectonic deformation along active faults. The surface ruptures were observed in soils and caused damages in infrastructure. They were caused by (a) the differential seismic response of loose lithologies, (b) the lateral instability of surficial formations and (c) the liquefaction of underlying formations. Liquefaction was manifest in the form of small sand boils involving clean sand in the vicinity of drainage channels and coastlines. The structural damage occurred in the western flat area and in the central and southern hilly area of NW Peloponnesus and mainly in settlements founded at basins formed in the

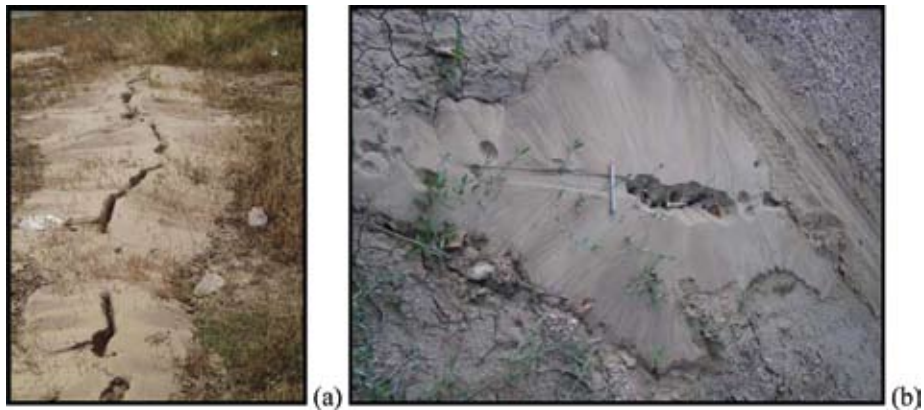
Figure 5. (a) Cracks and flows of liquefied material observed in Kato Achaia area. (b) Sand boils in the Nisi area.

involving clean sand in the vicinity of drainage channels and coastlines. These areas are (a) Kato Achaia (Figure 5a), (b) Manolada beach and (c) Nisi village (Figure 5b). It is important to note that liquefaction phenomena did not take place in Vrachneika area where considerable tectonic coastal subsidence took place or in Pineios delta area where liquefaction and other forms of ground failure were observed during the earthquake of October 16th 1988 in Kyllini peninsula (Mariolakos et al. 1989, Lekkas et al. 1990) and the earthquake of December 2nd 2002 in Vartholomio.

Liquefaction phenomena in Kato Achaia were detected at two sites both close to the sea. The first site was approximately 700 m north of the Kato Achaia train station about 30 m from the sea, with sand boils, empty cracks and cracks with flows of fine—grained silty liquefied material (Figure 5a). The second site was located in Kato Achaia beach 200 m west of the first site and was characterized by sand boils accompanied by flows of sandy silty liquefied material. In contrast to the first site the surface fractures and the lateral spreading were limited.

The liquefaction was also observed in the Nisi wider area including sand boils, surface fractures and flows of liquefied material (Figure 5b).

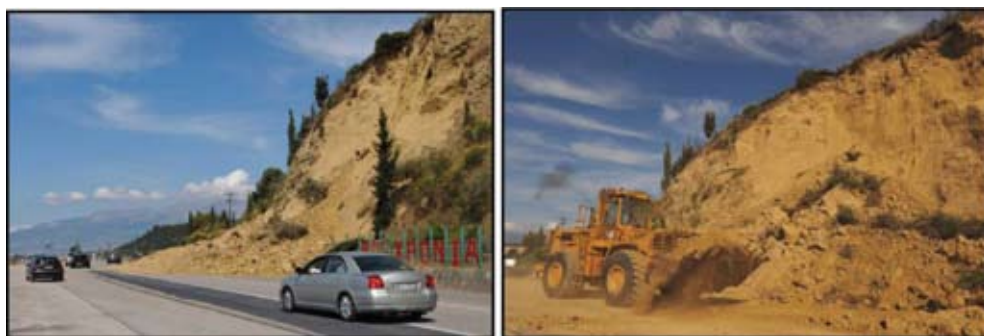
Figure 6. Landslides along the national road from Patras to Pyrgos near Vrachnaiika.

The Andravida earthquake triggered a number of landslides and rockfalls over a wide area, including: (a) along the national road from Patras to Pyrgos near Vrachnaiika, where sliding of marls took place along bedding planes and joints dipping towards the road (Figure 6), (b) along the national road from Patras to Corinth near Diakofto, (c) along the national road from Ancient Olympia to Tripolis near Lefkochori village, where rock toppling failures of limestones took place along the active Lefkochori fault zone (Fountoulis et al. 2007a, b), (d) in the wider area of Pigadi and Simiza villages along the active Pineios fault zone (Mavroulis 2009), (e) in the wider area of Santomeri and Portes villages at the western foothills of Skolis Mt where rock toppling failures of limestones took place, (f) along the road from Portes to Valmi village and along the road near Tsoukalaiika in Achaia and near Latzoi and Neraida in Iliia, where sliding of formations consisting of alternations of marly clays, silts, sands with consolidated or non consolidated conglomerates took place.

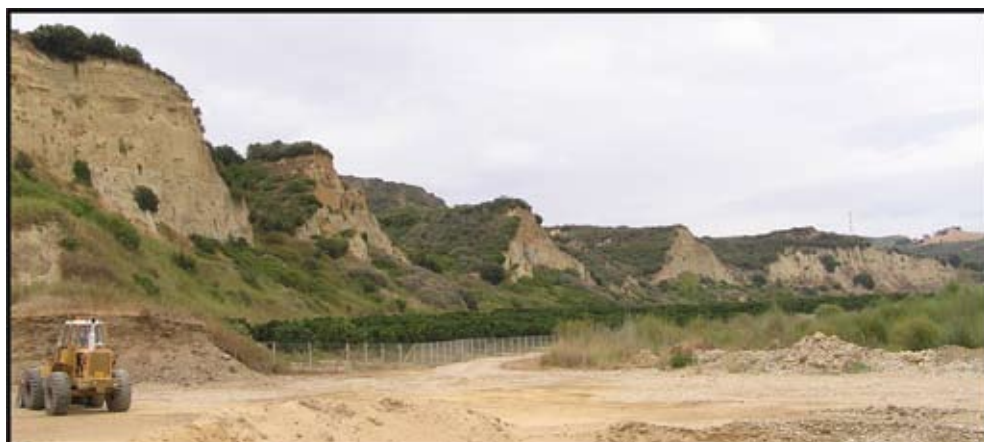
Figure 7. Landslides triggered by the Andravida earthquake along the active Pineios fault zone north of Ilida. The Pineios fault zone is the youngest active tectonic structure in the study area and almost transversal to the dextral strike—slip zone that causes the earthquake. It was not activated by the earthquake.
