Damage pattern, bedrock geology and surface ruptures of the 2009 L'Aquila event and implications for seismic hazard planning

ABSTRACT: This paper examines how the damage pattern of the 2009 $M_w = 6.3$ L'Aquila event correlates: a) with the bedrock geology, b) the amount of uplift/subsidence values recorded by the DInSAR analysis and c) the fault geometry. Moreover, it examines the widespread primary and secondary surface ruptures and the implications for the seismic hazard assessment for planning and design purposes. The amount of the DInSAR recorded uplift or subsidence values do not correlate to the damage pattern, implying that bedrock geology is the predominant factor that explicitly overshadows all other effects.

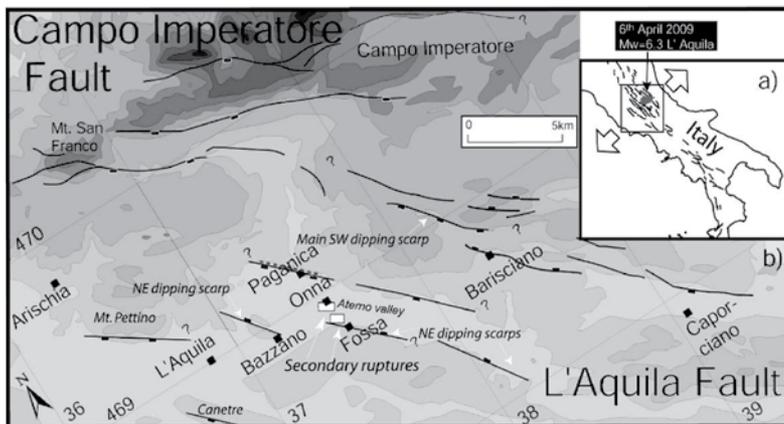
Figure 1. Map of the Italian Peninsula showing the active faults, the NE-SW extension occurring in Abruzzo and the epicenter of the 6th of April 2009 $M_w = 6.3$ event (Roberts et al. 2002). b) Detailed topographic map in L'Aquila showing the fault segments and the primary surface ruptures with red dashed line (modified from Michetti et al. 2000, Roberts and Michetti 2004, Papanikolaou et al. 2005).

The earthquake occurred on one of the NW-SE trending normal faults that form part of the 800 km long segmented normal fault system (Fig. 1a) that accommodates extension in the Apennines (e.g. Anderson and Jackson 1987, Roberts et al. 2002). These faults tend to generate strong events from $M = 5.5$ up to $M = 7.0$ and depending on the magnitude and the earthquake depth can produce from minor to severe damages and occasionally destruction (Michetti et al. 1996, Galadini and Galli 2000, Roberts et al. 2004). The town of L'Aquila is not only surrounded by several active normal faults, but is situated on their hangingwall as well (Fig. 1b). Each major fault comprises of several overlapping segments, closely spaced parallel segments and even antithetic structures. These antithetic structures are all high angle normal faults and closely spaced (~3–4 km) with the main faults, so that in most cases are linked at depth. This is the case of the L'Aquila fault that creates a complex fault structure, often leading to different interpretations.

The L'Aquila fault is a 37 km long structure that strikes northwest-southeast and down-throws to the southwest (Roberts and Michetti 2004). This fault has a rather complex structure, since it comprises several overlapping segments some of which are antithetic to the main SW dipping fault plane (Papanikolaou et al. 2005). These antithetic planes are nicely observed northwards the village of Barisciano, have fresh looking fault planes and are probably kinematically linked to the NE dipping Bazzano—Fossa fault segments in the southern part of the valley. The Mt Pettino, the Paganica segment (or Aquilano fault Boncio et al. 2004) and the antithetic Bazzano—Fossa fault outcrop on either side of the valley (Michetti et al. 2000) and form part of the same system. In a few words the strain in the area is accommodated on multiple closely spaced synthetic and antithetic overlapping segments. Therefore, the fault zone is characterised by distributed displacement on several overlapping faults that break up the footwall and the hanging wall into smaller blocks. This earthquake has activated one of the fault segments of the L'Aquila fault that bounds the northern part of the Aterno valley in Paganica (Fig. 1b, Michetti et al. 2009).

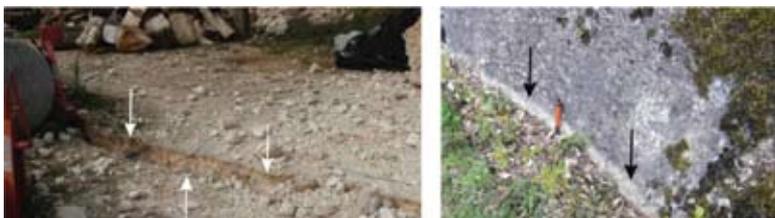
Figure 2. Views of the primary surface ruptures in Paganica (left) and the secondary surface ruptures in the Bazzano fault (right) (courtesy E. Vittori).

Primary surface ruptures represent the surface expression of the activated seismogenic fault. They were discontinuous, but well aligned and could be traced up for at least 2.6 km with maximum displacements not exceeding 10 cm in Paganica (Michetti et al. 2009, Fig. 2). Due to the moderate magnitude of this earthquake, primary surface ruptures had small displacements that did not exceed 10–12 cm, implying that it was difficult to distinguish between primary and secondary ruptures. However, all researchers agree that the surface ruptures traced in Paganica were primary and this occurs not only because they correlate well with the focal mechanism and the epicenter locality, but also due to the DInSAR analysis that provides a clear view of the surficial deformation pattern (see also Section 6). The DInSAR predicted fault surface ruptures coincide with the ground surface ruptures observed in Paganica, confirming that the ruptures observed near Paganica were indeed primary. Additionally, these ruptures broke a 0.7 m diameter high pressure water pipeline in Paganica.

Several secondary surface ruptures occurred on neighboring pre-existing fault planes. Several reports describe such ruptures in the Roio—Canetre fault, the NE dipping Bazzano fault, where a 5–8 cm white stripe at the base of the limestone fault scarps was observed (Fig. 2) and locally on the Mt. Pettino segment and the Campo Imperatore fault (Blumetti et al. 2009, DST Working Group—Uni CHB 2009, INGV-Emergeo Group 2009, Michetti et al. 2009).

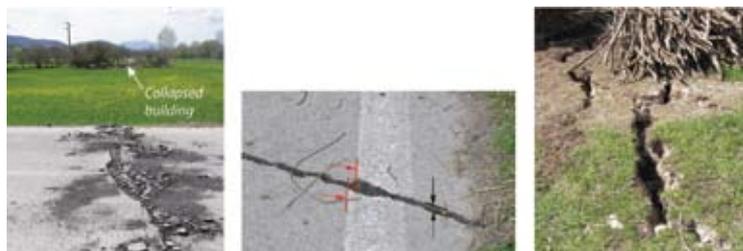
Figure 3. View of the secondary ruptures near the village of Onna.

Tens of secondary surface ruptures were widespread within the recent sediments of the Aterno basin, reaching up to several tens of meters long (Fig. 3). They are highly correlated with the damage pattern since the majority of them occurred near the village of Onna that suffered the highest damages. These secondary ruptures are several tens of meters long and up to 30 cm wide and are all strictly NW-SE trending parallel ($150^\circ \pm 20^\circ$) to the activated fault plane. They are mostly observed near the river as well as on manmade road embankments (Fig. 3). Overall, these

secondary ruptures appeared in artificial and natural structures that are prone to rupturing. Most of these ruptures were transverse to the road network, producing cracks in paved roads that are several meters long and having offsets both horizontal and vertical of several cm (up to 6 cm).

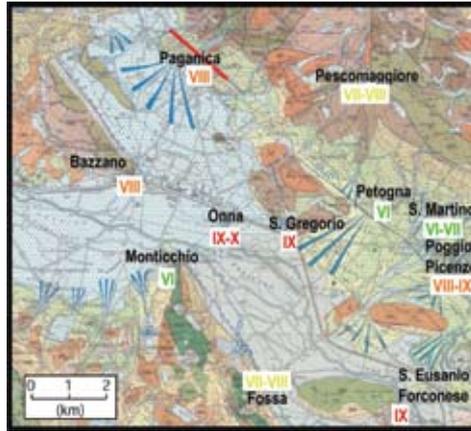
Figure 4. View of the official geological map (CARG N. 359 L'Aquila) in the epicentral area. Superimposed are the primary surface ruptures and the intensities recorded by the Quest 2009 team. Intensities are highly influenced by the bedrock geology.

The macroseismic epicentre was the village of Onna (MCS intensity IX-X) that suffered the highest damages and recorded the highest death toll (losing 10% of its population), located about 12 km east from the earthquake epicentre, whereas the town of L'Aquila suffered intensity VIII-IX (Quest 2009). In Figure 4, the MCS intensity values assessed from the Quest team, have been superimposed on the official 1:50.000 scale geological map of the area.

Despite the fact that the fault plane ruptured up to the surface near the Paganica village, it is interesting to note that the Paganica village suffered moderate damage (VIII). Several other neighboring villages in the immediate footwall of the ruptured plane, such as Pescomaggiore, Petogna and San Martino, experienced minor to moderate damages (VI up to VII-VIII). On the other hand, villages located within the Aterno Basin in the hanging wall, suffered significant damages (Onna IX-X, San Gregorio IX, Villa Sant'Angelo IX, Sant' Eusanio Forconese IX). The majority of the damages in these villages relate to old masonry buildings (Fig. 5). Overall, the damage pattern is elongated along a NW-SE direction, which reflects the activated fault plane, the elongated geological structure of the recent sediments of the Aterno valley and involves also some directivity effects. The damage pattern varies over short distances due to changes in bedrock geology. The most striking example involves the villages of Onna and Monticchio that are only 1.5 km apart, but their MCS recordings differ up to 3.5 intensity values. The Monticchio village is founded on bedrock (limestones) and recorded intensity VI, whereas the village of Onna is founded on recent alluvial sediments underlain by 100 m of lacustrine sediments and recorded intensity IX-X (Fig. 4).

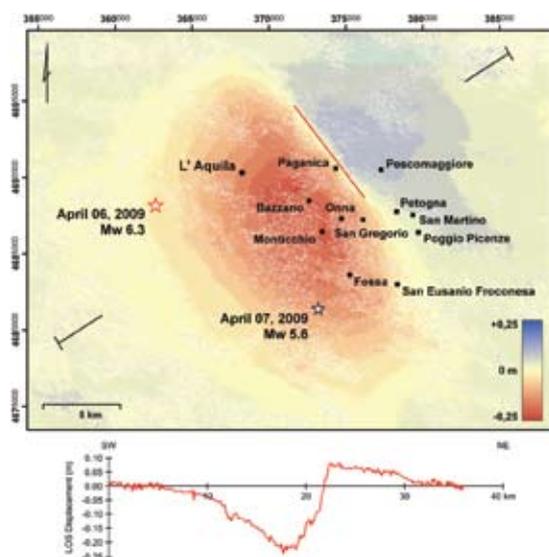
Figure 6. View of the DInSAR deformation field and the predicted primary fault surface rupture locations. Cross section is across strike of the activated fault plane and shows the uplift and subsidence in the footwall and hanging wall.

The Differential Radar Interferometry (DInSAR) technique has been used to detect surface displacements in the order of a few centimetres. This technique combines and merges two radar images acquired before and after the earthquake in order to trace the differences caused by the earthquake, offering a detailed view of the deformation pattern. Figure 6 shows the differential interferogram, whose pattern is asymmetrical since the deformed area is significantly expanded to the southeast. The deformed area is about 460 km², of which 66% (or 305 km²) has subsided and the remaining 34% (or 155 km²) has been uplifted (Papanikolaou et al. 2010). The maximum observed uplift was about 10 cm and was recorded a couple of km northeast from the Paganica surface ruptures in the immediate footwall of the fault, whereas the maximum subsidence was 25 cm and was observed about 2 km SW from the NE dipping Bazzano fault. A cross section drawn across strike of the activated fault plane, showing the uplifted and subsided area, allows the fault trace to be easily traced with high precision (Fig. 6). The DInSAR predicted fault surface ruptures coincide with localities where surface ruptures have been observed in the field, confirming that the ruptures observed near Paganica are indeed primary. This is an important outcome because this earthquake as demonstrated previously produced both primary and secondary ruptures of similar displacements, many of which occurred on pre-existing fault planes. The latter implies that it was

We tried to test whether the amount of uplift or subsidence that each locality experienced (Fig. 6) is correlated to the damage pattern (Fig. 4). Displacement values were extracted from the DInSAR and correlated to the macroseismic intensity values MCS (Quest 2009). Table 1 displays the displacement and intensity values and Figure 7 shows that there is no correlation between the recorded amount of uplift or subsidence values and the macroseismic intensity.

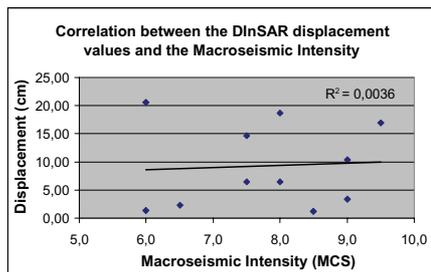
Figure 7. Diagram showing that there is no correlation between the amount of uplift or subsidence and the intensity values.

The majority of the damages in these villages relate to old masonry buildings so that the building stocks are of the same construction quality. There is no correlation even if uplift or subsidence values are examined separately. It is interesting to note that the village of Paganica in the immediate hanging wall of the activated fault, where the primary surface ruptures were recorded, was subsided for only 6.4 cm and experienced intensity VIII. On the other hand, the village of Onna that was the macroseismic epicenter experienced intensity IX-X and subsidence of 17 cm, whereas the village of Monticchio that was only 1.5 km away from the village of Onna and 4 km away from the primary surface ruptures, subsided 20.5 cm but experienced macroseismic intensity of only VI.
