Environmental effects caused by the Andravida (08-06-2008, ML=6.5, NW Peloponnese, Greece) earthquake

S. Mavroulis, I. Fountoulis & E. Lekkas

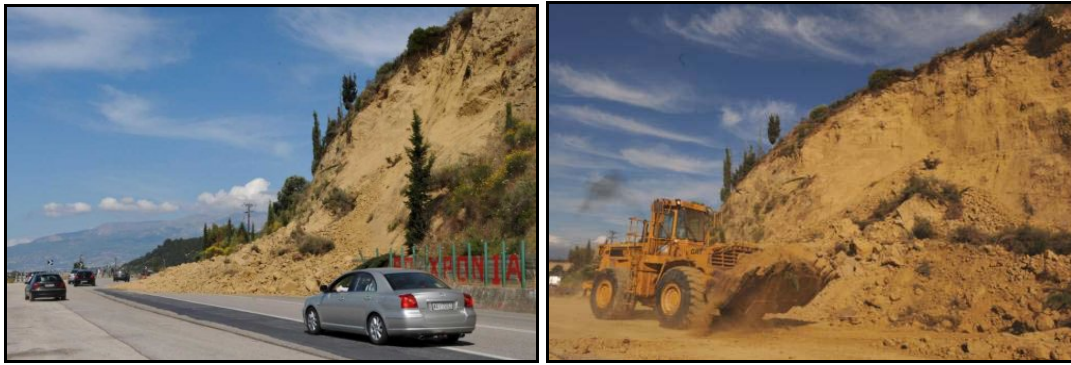
Figure 6. Landslides along the national road from Patras to Pyrgos near Vrachnaiika.

The Andravida earthquake triggered a number of landslides and rockfalls over a wide area, including: (a) along the national road from Patras to Pyrgos near Vrachnaiika, where sliding of marls took place along bedding planes and joints dipping towards the road (Figure 6), (b) along the national road from Patras to Corinth near Diakofto, (c) along the national road from Ancient Olympia to Tripolis near Lefkochori village, where rock toppling failures of limestones took place along the active Lefkochori fault zone (Fountoulis et al. 2007a, b), (d) in the wider area of Pigadi and Simiza villages along the active Pineios fault zone (Mavroulis 2009), (e) in the wider area of Santomeri and Portes villages at the western foothills of Skolis Mt where rock toppling failures of limestones took place, (f) along the road from Portes to Valmi village and along the road near Tsoukalaiika in Achaia and near Latzoi and Neraida in Ilia, where sliding of formations consisting of alternations of marly clays, silts, sands with consolidated or non consolidated conglomerates took place.

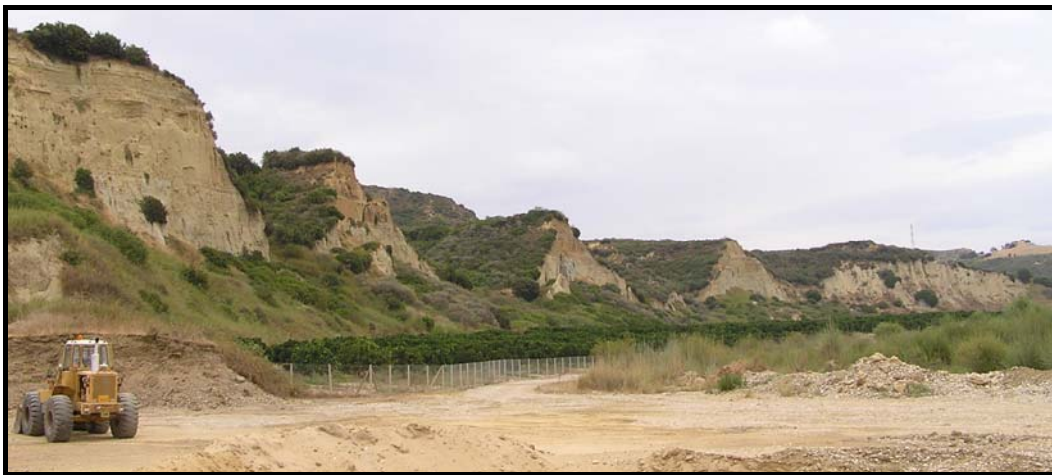
Figure 7. Landslides triggered by the Andravida earthquake along the active Pineios fault zone north of Ilida. The Pineios fault zone is the youngest active tectonic structure in the study area and almost transversal to the dextral strike – slip zone that causes the earthquake. It was not activated by the earthquake.
