MARIOLAKOS, I., FOUNTOULIS, I. & ANDREADAKIS, M., (2000). – Engineering Geological problems caused by human interference on monuments that influence their seismic behaviour. In RAPHAEL programme – COMARECH, “Compatible materials and techniques for earthquake and monuments protection”, p. 53-63, Istanbul, October 2000.

ENGINEERING GEOLOGICAL PROBLEMS CAUSED BY HUMAN INTERFERENCE ON MONUMENTS THAT INFLUENCE THEIR SEISMIC BEHAVIOUR (FOUR CASE STUDIES)

I. Mariolakos, I. Fountoulis & E. Andreadakis

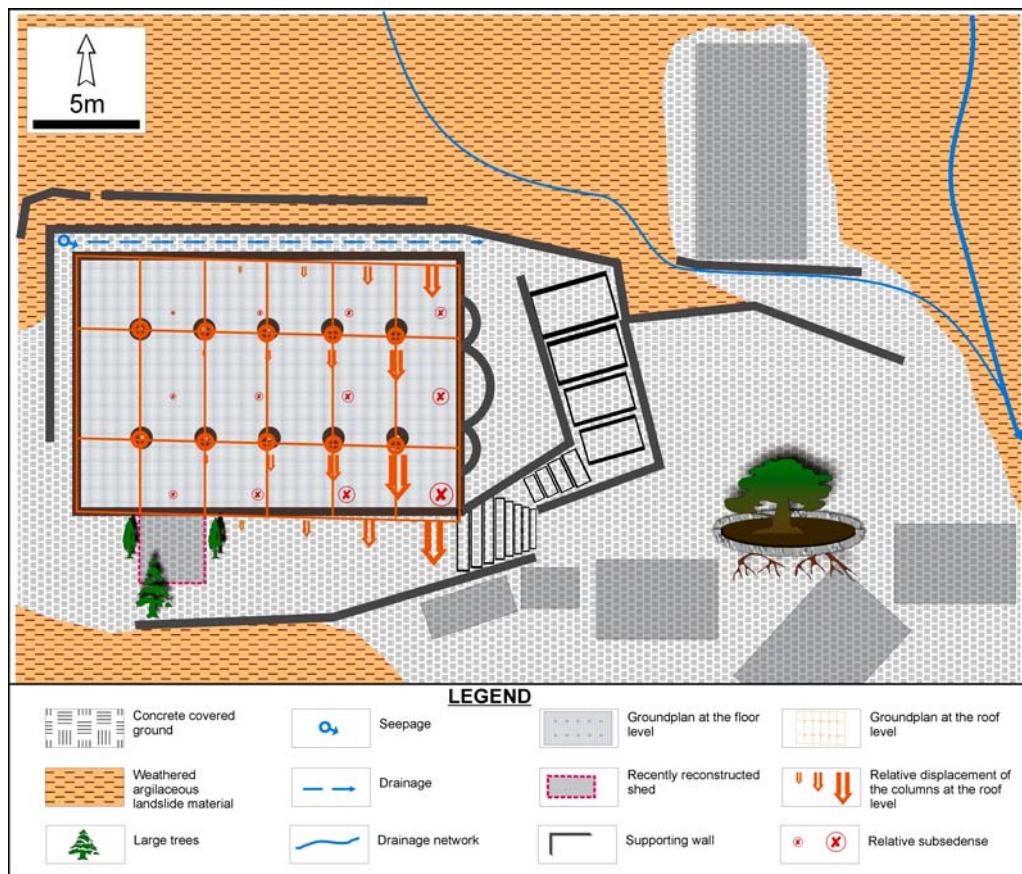
Figure 6: Sketch map of the monument in Paleoselli and the surrounding area.

There seems to be a mechanism of differential subsidence, directly connected to the differential saturation of the soil. The spatial differences of saturation created different plasticity and compressibility conditions, which, combined with the heavy load of the building, triggered differential subsidence. Thus, the northeast area is supersaturated, while the southeast area is undersaturated, because of the interruption of the subsurface water drainage by the construction, and the absorption of large amount of underground water by the sycamore tree. No fractures have damaged the walls, because of the excellent framework with joints of the pillars and the walls with metallic elements and beams.

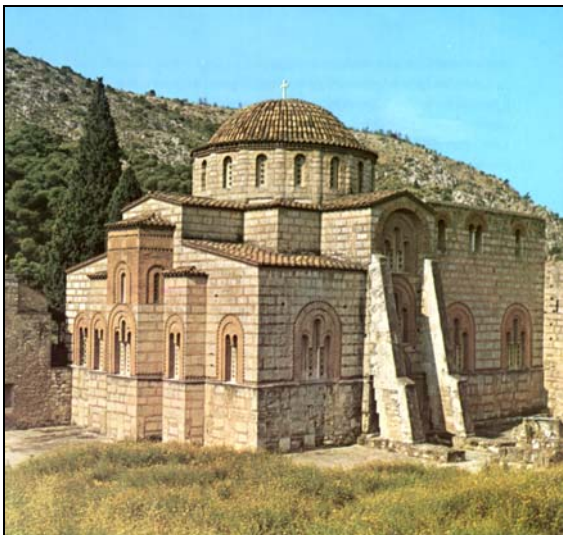
Figure 10: The temple of Assumption.

The monastery is sited in a neogene tectonic graben between the mountains Egaleo and Korydallos, at the west side of the basin of Athens (Figure 12). The temple was built in 11th century AD, replacing an older church. Large-scale damages are reported in the 13th century, and an overhaul took place in the 14th century (Figure 10). Extended damages occurred during the latest Athens earthquake (September 7th, 1999).
